# DAMAGE ASSESSMENT FORM

Building Name 24850 SW 187TH AVE (REDLAND DISTRICT RESIDENCE)

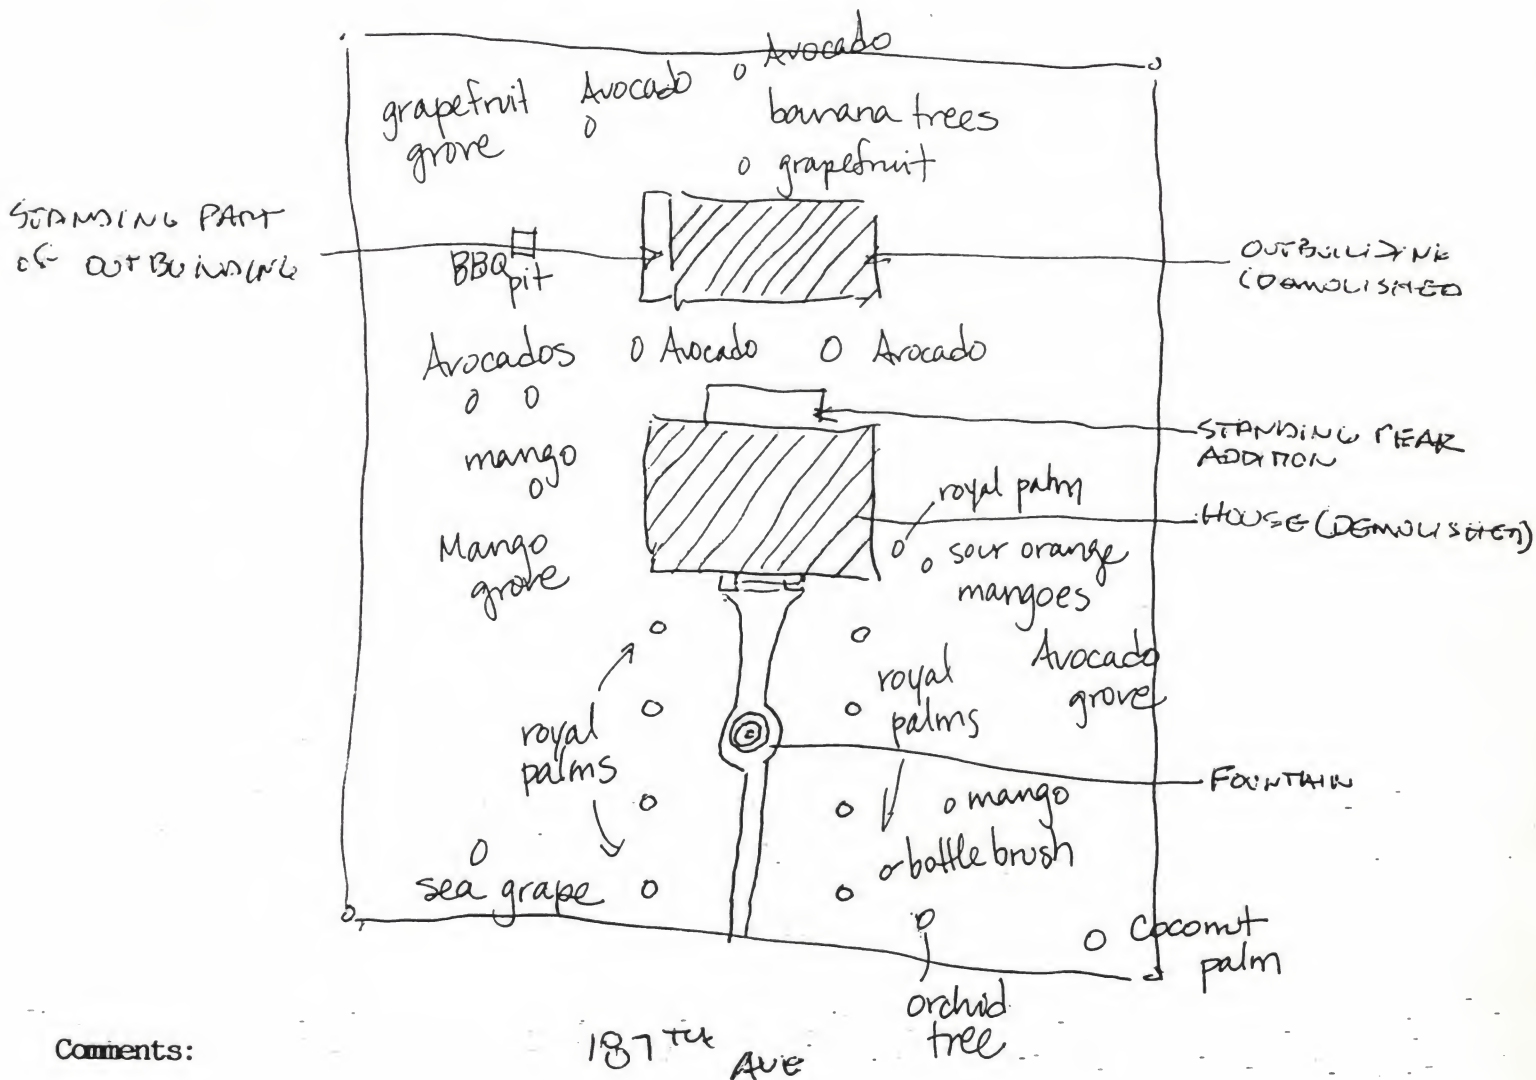
## Site Sketch:

(Significant landscape features, large old trees, (standing/down) walls, paths, groves (type)).
